CLIENT: GENYK

| Test Report No: T1296-6 | Report Date: December 7, 2020 |

- **SAMPLE ID:** Genyk wall assembly containing Boreal Nature Elite medium density spray applied polyurethane foam insulation with cement board and stucco finish.

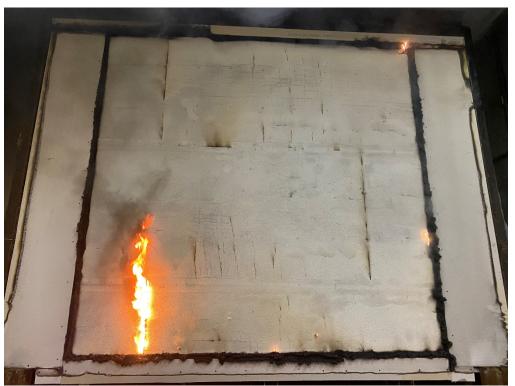
Figure 6: The exposed face after the fire test.

After the wall was rolled away from the furnace it was observed that there were no openings in the protective barrier when viewed normal to the face.

The cement board protective barrier remained in place for the duration of the test. There were a few small areas where the stucco finish had deteriorated but there were no through openings through to the spray foam insulation. The protective barrier did not deteriorate in a manner that flame could propagate along the panel surface.
