In-situ Performance Evaluation of Exterior Insulation Basement System (EIBS) – Spray Polyurethane Foam Summary Report

M.C. Swinton, M.T. Bomberg, M.K. Kumaran, W. Maref, N. Normandin,
R.G. Marchand

Internal Report No. 820

Date of Issue: November 2000

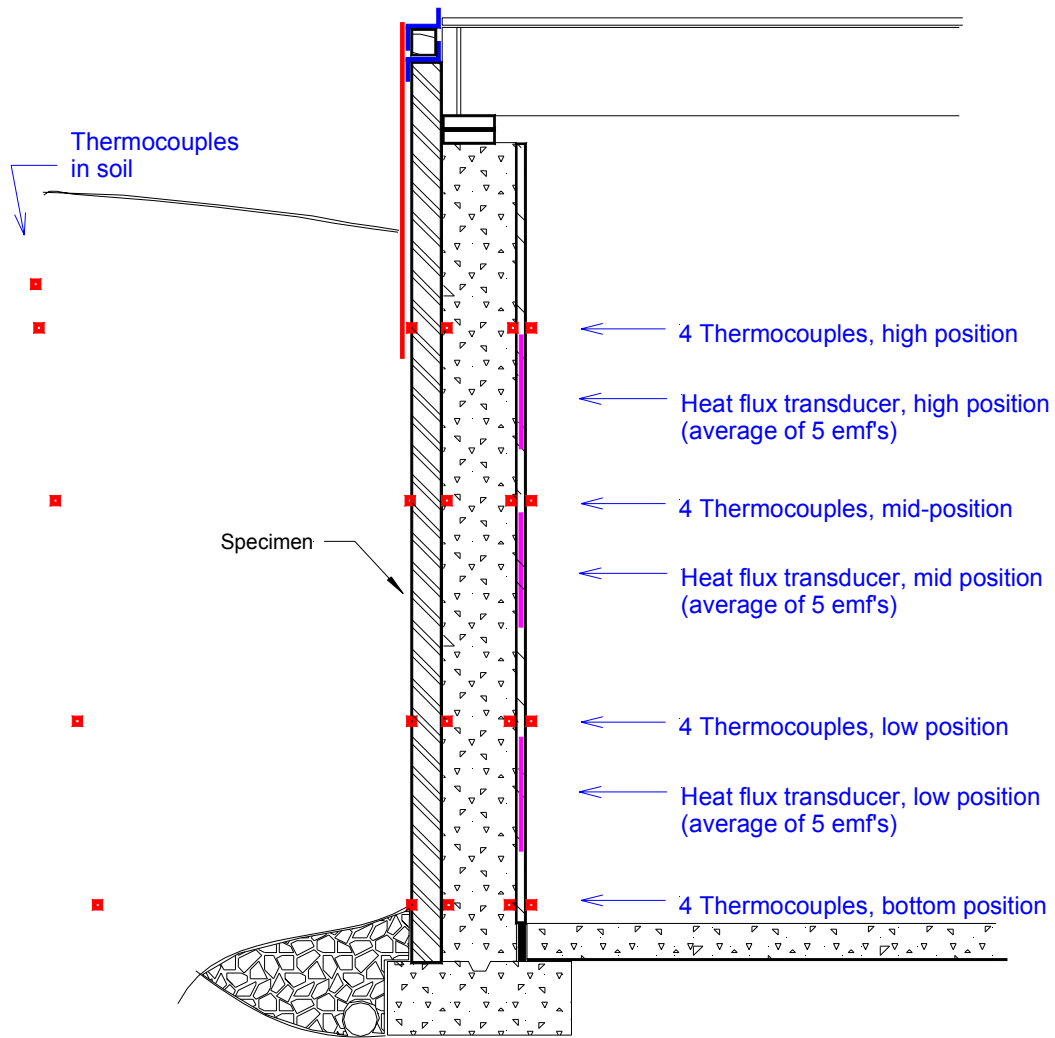
Figure 1. General Layout of Insulation Specimens and Sensors

The SPF specimens were sprayed over the full height of two 1220 mm wide segments of the exterior basement wall of Test Hut #1, at NRC's main Campus in Ottawa. Their performance was monitored using a strategy developed to monitor the in-situ thermal performance of roof insulation^{2,3}. A thermally calibrated, 25 mm layer of expanded polystyrene board was installed over the entire surface of the interior of the basement wall. Thermocouples were systematically placed at the surface of each element in the wall, in a vertical array consisting of 16 points per specimen. A schematic diagram of this arrangement is shown in Figure 1. As well, heat flux transducers were installed at three vertical locations.

The field experiment consisted of installing an SPF specimen on each of the east and west basement wall of Test Hut #1. The specimens were instrumented as shown in Figure 1.

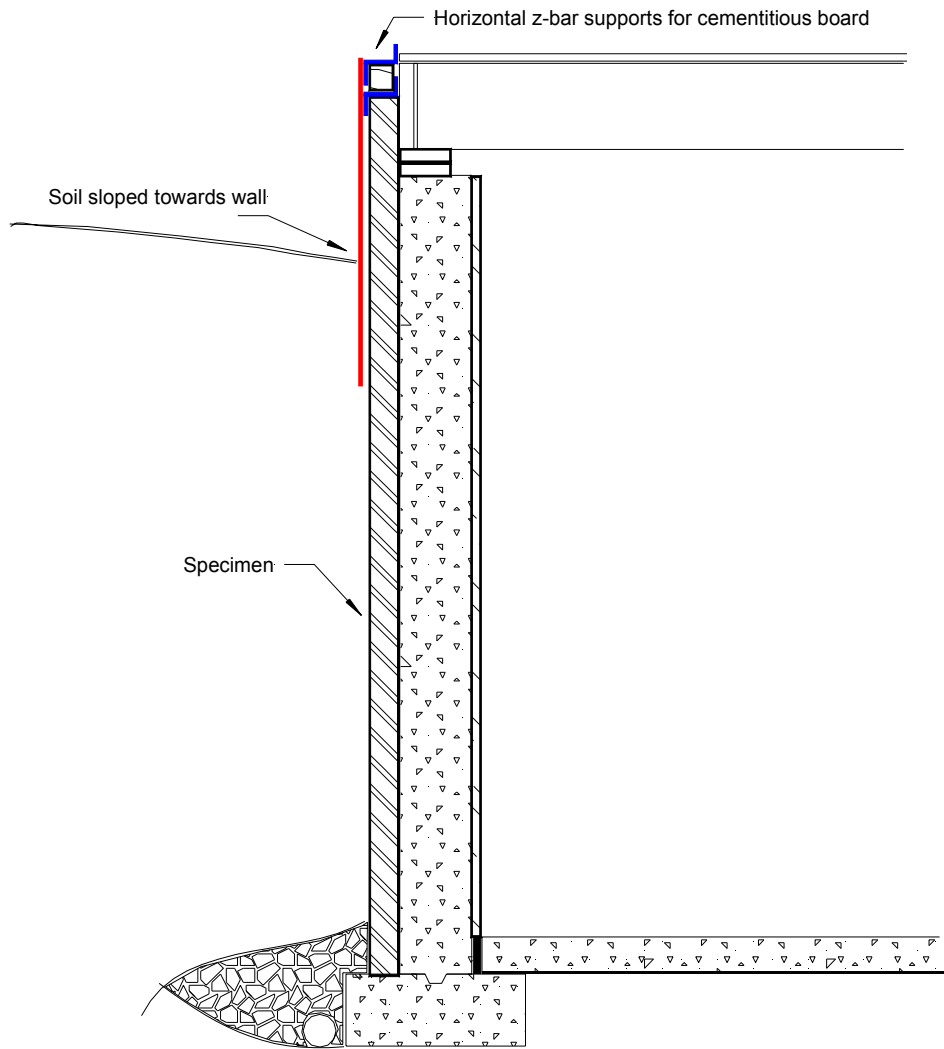
Figure 2. Installation System 1 for the Above Ground Protective Assembly - West Wall.

Two different installation methods were used on the east and west wall configurations, labelled System 1 and System 2 respectively. System 1 on the west wall (Fig. 2) featured two horizontal rows of metal z-bars, separated by a wood spacer, all fastened to the header. Once the insulation was in place, the cementitious covering boards were fastened to the z-bars and wood space. No other fasteners were used, so the cementitious board was effectively

'cantilevered' over the insulation specimens. The soil was sloped at 5% grade towards the wall, to simulate a settled condition.

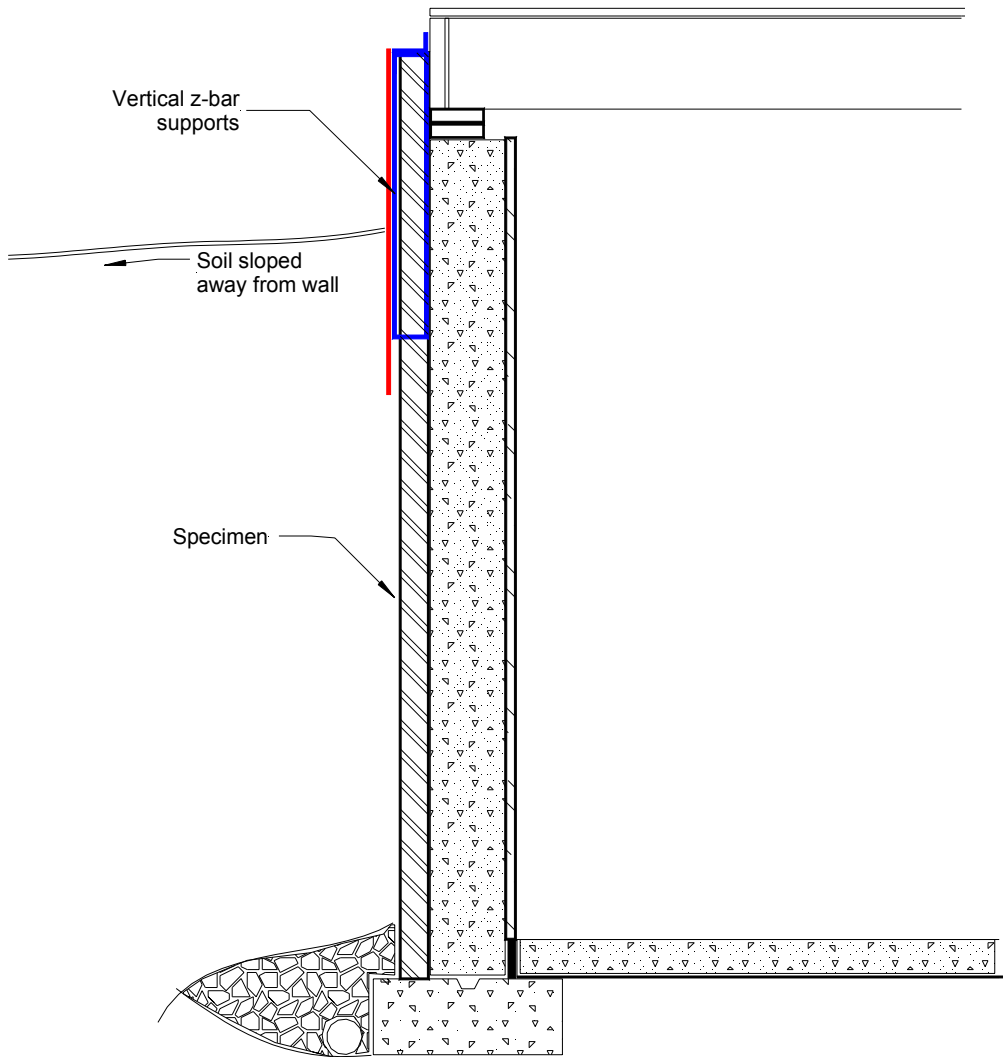
Figure 3. Installation System 2 for the Above Ground Protective Assembly - East Wall

System 2 on the east wall (Fig. 3) featured metal z-bar supports placed vertically between each insulation specimen. The z-bars were fastened directly to the concrete wall and wood header on the inside, and fastened to the cementitious board on the outside. Each metal z-bar was therefore a thermal bridge around the insulation. System 2 also featured an initial 5% sloped grade away from the basement wall.

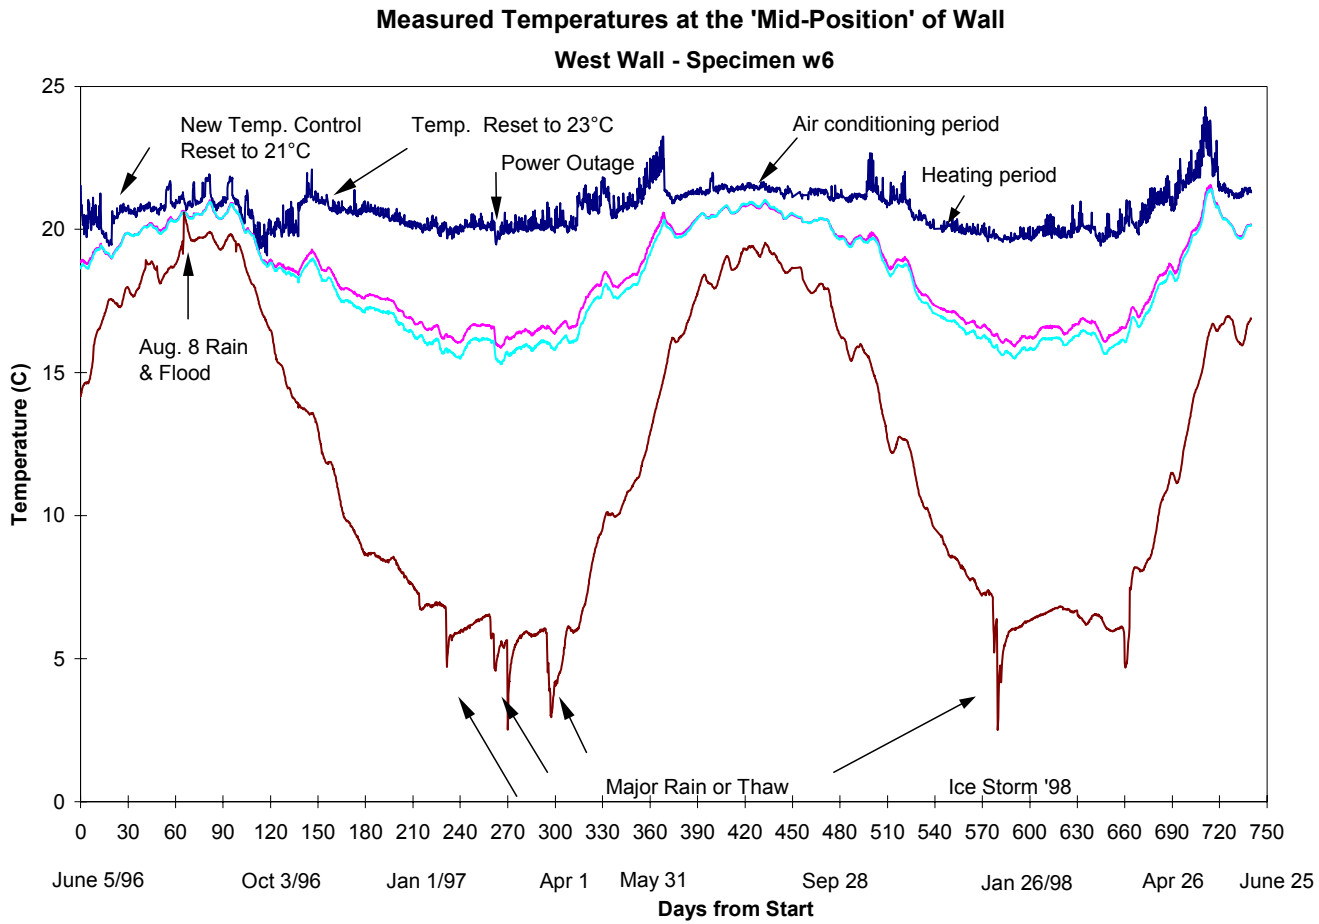
Figure 4. Temperature Profiles at the Mid-Position of Specimen W6 on the West Wall

Figure 4 shows the two-year temperature record at four locations through the wall at specimen W6: the interior surface, both sides of the concrete, and the exterior surface of the specimen in contact with the soil. The inner surface of the wall is kept near 21°C, with small variations throughout the two years. Main control events such as power outages and changes from heating to air conditioning and back are evident from these temperature readings. The temperature at both sides of the concrete are quite close to one another (concrete being a poor thermal insulator), and these vary from 15°C to 20°C, from winter to summer.

The lowest curve in the graph is the temperature record for the insulation/soil interface. These vary between about 5°C in winter up to a maximum of about 20°C in summer.

The periodic 'spikes' in this curve correspond to recorded events of heavy precipitation or winter thaws. The August 8, 1996 rain was a 1 in 75 year event for Ottawa, which caused local flooding around the test hut. During this storm, the temperature at the insulation/soil interface deflected upwards, apparently due

to warm rainwater moving down the wall. Such deflections were observed at the mid, low and bottom thermocouple positions during the same period, tracing the path of the water. These deflections were much less noticeable at the high position, where the soil temperature would be closer to the temperature of the moving water.

The temperature deflections in the winter at the soil/insulation interface are downward because the melt water temperature is initially 0°C, which cools the soil and insulation at the interface.

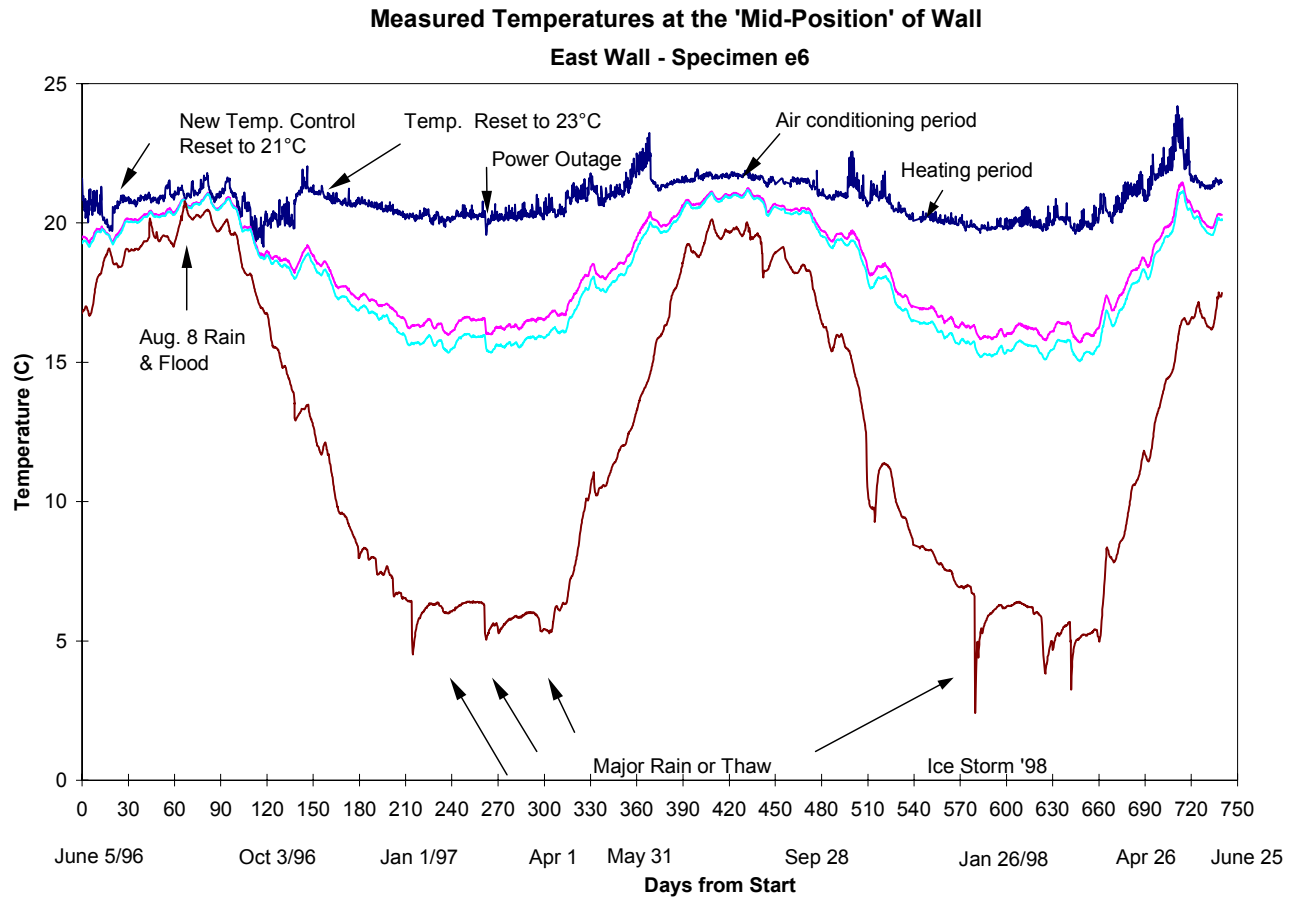
Figure 5. Temperature Profiles at the Mid-Position of Specimen E6 on the East Wall

Figure 5 shows temperature measurements on the east wall of the test hut for the same insulation product that was shown on the west side in Figure 4. In the first year, these periodic temperature deflections were often smaller or absent on the east wall where the ground surface was properly graded outward. This relative absence of temperature deflections can be observed in Figure 6 for the first winter.

In the second year however, the differences between east and west were less noticeable, and the temperature deflections were then quite noticeable. A final review of soil slopes near the wall revealed that by the end of the second year, most of the slopes had settled on the east wall. These slopes were now mostly inward.

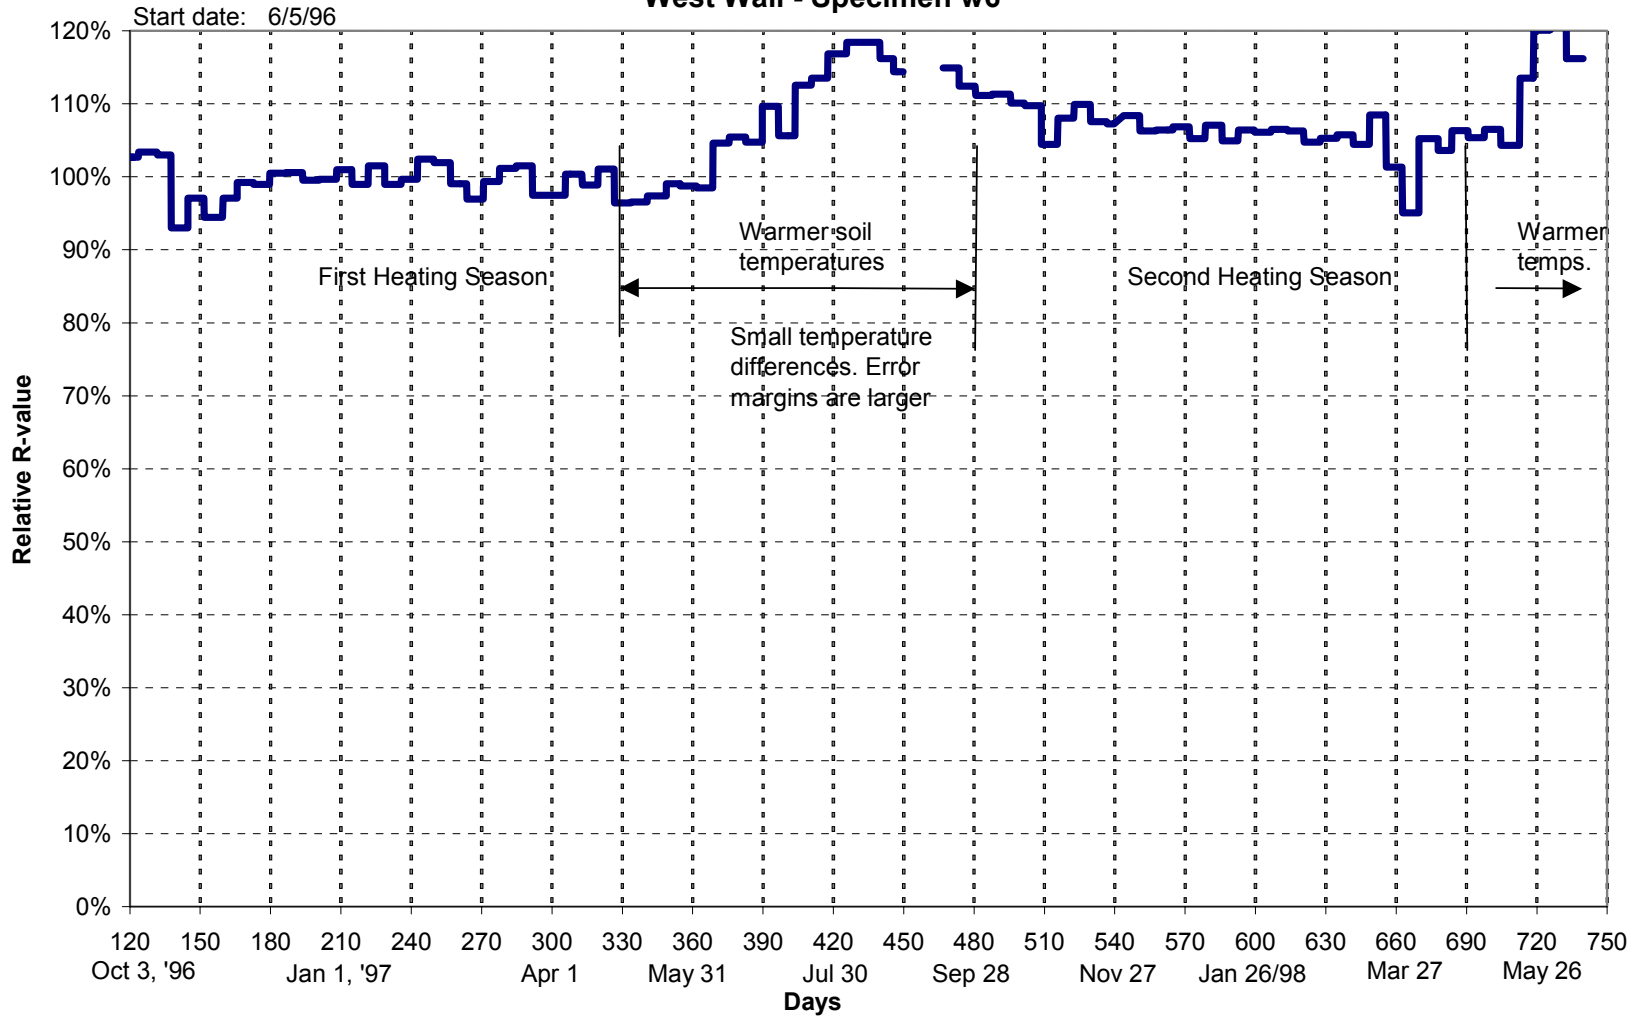
Weekly Average R-value of the Specimen Relative to the R-value for October 1996

West Wall - Specimen w6

Figure 6. Trend in R-value for Two Heating Seasons.
(Normalized to Initial R-value for October 1996)

Figures 6 and 7 show the resulting thermal performance plots for the specimens on the west face (a) and the east face (b). The change in thermal resistance adjustment is shown on a weekly basis over two heating seasons. Key observations are as follows:

- all specimens show relatively steady performance through the heating seasons
- the second heating season shows equal or improved performance for all specimens
- the results for the warm periods are unreliable, since the temperature difference across the specimens are very small (< 0.5°C). During such periods, thermocouple errors can be as large as the actual temperature difference.
- On day 215, modifications were made to faulty controls on the sump pump. Water levels around the footing were lowered over time. The sump pump connection is nearest specimens W5 & W6.
- Major rain and thaw periods do not appear to significantly affect the thermal performance of the specimens during these episodes.

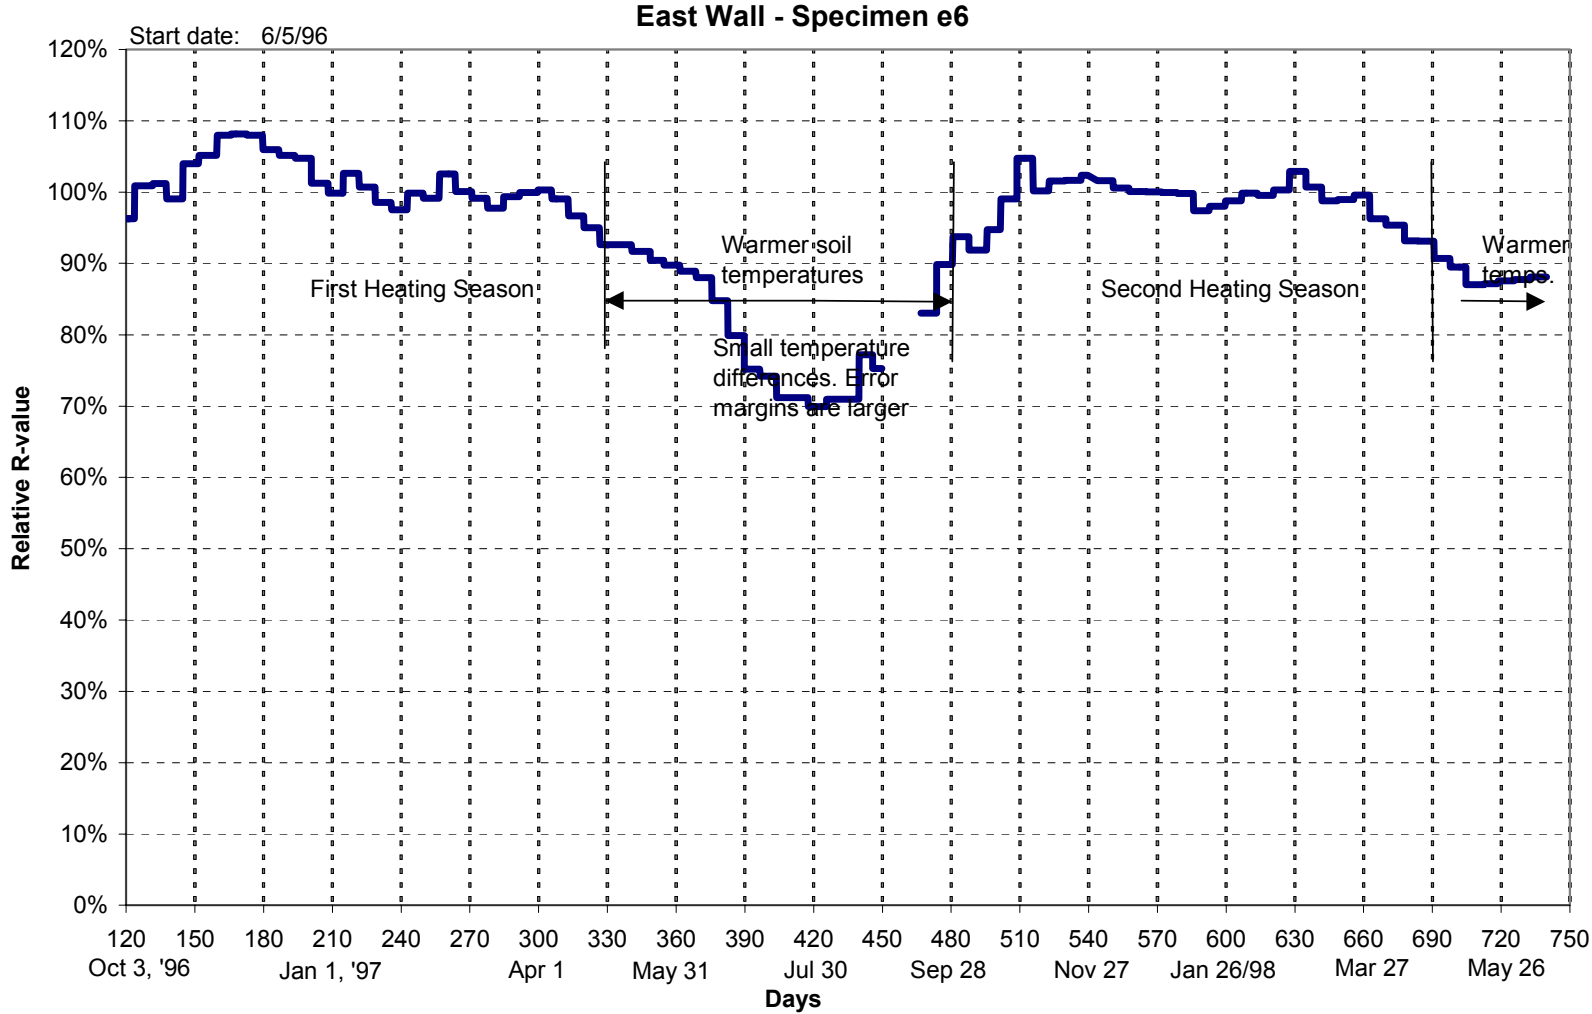
Weekly Average R-value of the Specimen Relative to the R-value for October 1996

Figure 7. Trend in R-value for Two Heating Seasons.
(Normalized to Initial R-value for October 1996)
