# Update on Compatibility Testing of Spray Polyurethane Foam with CPVC

## **ABSTRACT**

In response to the growing use of the combination of CPVC and spray polyurethane foam products (SPF) the Center for the Polyurethane Industry (CPI) and the Spray Polyurethane Foam Alliance (SPFA), along with Lubrizol Advanced Materials, Inc., a leading CPVC resin manufacturer, have conducted a study which assesses the compatibility of generic SPF and CPVC pipe and fittings. This research program has allowed the industry to assess the chemical, physical, and thermal compatibility of soy and non-soy based closed-cell polyurethane foam, soy and non-soy based open-cell polyurethane foam, and one component foam with CPVC pipe and fittings. Industry testing and current ASTM test protocols involve soaking the CPVC pipe in a liquid or solvent material. Foam presents an interesting challenge for compatibility testing since CPVC/foam compatibility does not involve the long term liquid contact of materials. Instead, the contact point is multi-cellular foam on a smooth plastic surface. This paper discusses the outcome of sample testing and includes a physical and analytical assessment of the foam and CPVC.

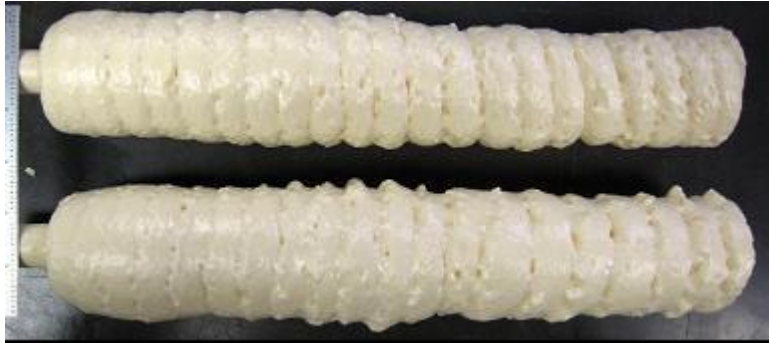
**Figure 6.** One Component foam sample

Traditionally one component foam has limited contact with a CPVC pipe surface because it is used to seal or fill gaps. Because of the elevated temperature of the test it was agreed that the test pipe would be covered with one component foam. However, it would only be applied at 1 inch thickness. In order to insure that the foam exposure resembled traditional building practices the pipe was placed in a jig. It was rotated as a continuous bead of foam was applied to the pipe. Figure 6. Illustrates what the final sample looked like.

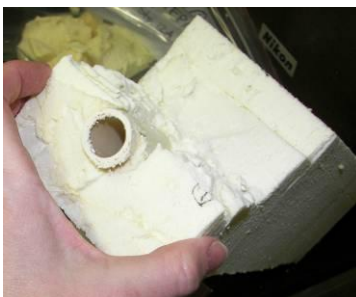
*Figure 8. Foam sample removed for testing*

A section of foam was removed from the pipe assembly and transferred to the analytical lab for testing. The foam samples were prepared and analyzed using the GC method for FR identification. In the next step ICPOES (Inductively Coupled Plasma Optical Emission Spectroscopy) was used to determine the % P level in the foam.

For the total phosphate analysis (% P level) in the foam a known weight of foam was digested with a known volume of concentrated nitric acid in a closed microwave digestion vessel. The microwave digestion program slowly ramps the Teflon digestion vessels to 230°C, holds for 10 minutes and then allows the vessels to cool down to room temperature. The foam samples are completely digested following this program. The vessels are then opened, contents transferred to a volumetric flask and diluted to volume with DI water. The digested samples are analyzed for total phosphorus content by ICPOES (Inductively Coupled Plasma Optical Emission Spectroscopy). Calibration standards covering the range of the samples are made up to match the acid concentration of the samples. A nitric acid blank sample that was carried through the digestion procedure is also analyzed.
